A PRELIMINARY ASSESSMENT OF THE IMPACT OF THE TSUNAMI ON THE CORAL REEFS OF TUTUILA ISLAND

**Department of Marine and Wildlife
Resources**

**Report Prepared by:
Douglas Fenner, Lucy Jacob,
Domingo Ochavillo, Marlowe Sabater**

October 7, 2009

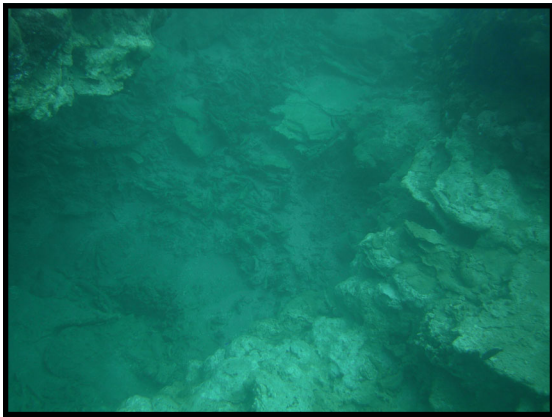
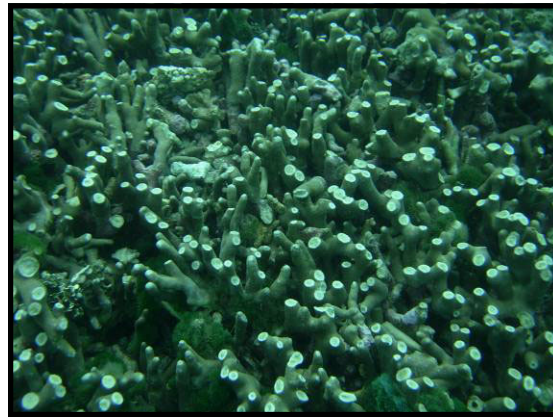
Vatia

Substantial overturned rubble and new chutes scoured into the substrate. There were evidence of broken corals, sedimentation and fresh coral death. However, many corals remained healthy and attached, particularly those that were attached to mounds. Debris was minimal compared to other sites. There was some unusual bleaching of some coral colonies.

The eastern side was examined. There was lots of white or light brown/orange rubble in chutes on the reef slope. Such chutes began in ava-shaped (V-shaped) cuts in the

edge of the reef flat. Near the reef flat they show signs of powerful scouring, with several feet of white reef rock exposed on the lower side of the chute, and no rubble on the bottom. Farther from the edge of the reef flat, the rubble began in the chute, and extended down to around 40 feet or more in some of the chutes. There may have been some sorting so that small stick rubble was nearest the top of the slope, and pieces of table tops were near the bottom of the chute. In between chutes there were steep slopes that had coralline algae and coral and were undisturbed. In some places there were large lumps with coral on their tops and sides. *Porites cylindrica* and *Porites rus* colonies rarely had any damage, though in a few places many branch tips of *P. cylindrical* were broken off. On large colony of *P. cylindrical*, perhaps 8 feet by 4 feet, was tipped on its side, with the live branches pointing toward the center of the bay, as though it had been pushed over by water coming from the direction of the shoreline. Many tables, perhaps 20% of tables, had central areas that appeared to be a light brown and were partly filled between branchlets. Feathering water by hand revealed it was sand that had settled on the table and killed the tissue under it, so the lower sand was often black. These areas ranged from around 10 cm diameter up to nearly the entire surface of large tables over a meter diameter. Nearer to the head of the bay the chutes were larger and more abundant than out closer to the mouth of the bay. The direction of the chute of rubble was straight down the slope toward the center of the bay, so perpendicular to the shoreline, at right angles to a line from the head of the bay to the mouth of the bay. The V-shaped cuts in the edge of the reef flat that led to lower areas of the reef slope than surrounding areas was a pre-existing feature of this reef slope, that somewhat resembles spur and groove formation. The bottom of the grooves had some coral and some sand and rubble. No live coral remains in these rubble fields. It appears that the scoured chute heads were formed by large volumes of water pouring off of the reef flat, when the tsunami had covered the reef flat with a water perhaps 15 feet deep, and then the water level quickly dropped, and the water on the reef flat cascaded over the edge of the reef flat in huge volumes which scoured the head of the chute, removing large amounts of buried rubble from the head of the chute where it had accumulated from prior disturbance events such as hurricanes and/or the crown-of-thorns outbreak of 1978, and moving it down slope. Rubble on the rubble bar in the middle of the reef flat had also been moved such that white and orange rubble that had been buried there were moved to the surface. There are also some microatolls on the reef flat there, and they showed strong scour around them, exposing about 20 cm depth of white rock that had been buried.

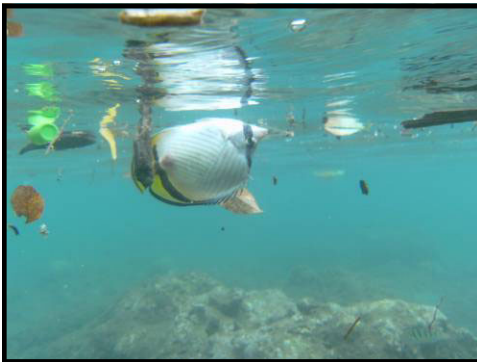
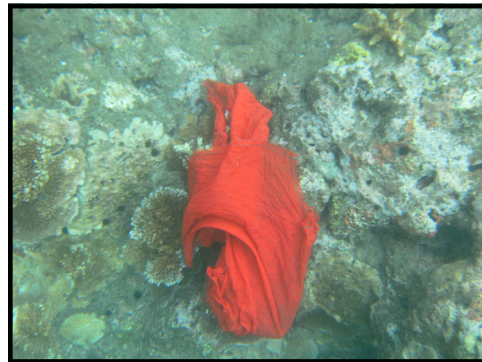
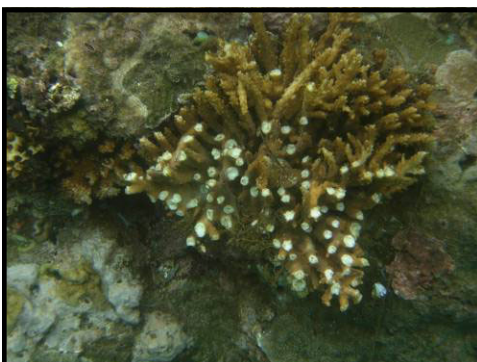
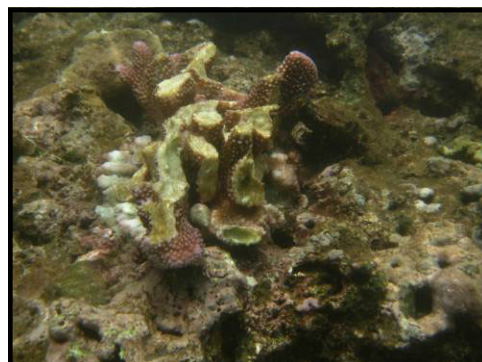
Fagasa

Many small corals (*Acropora sp.*) had broken branches and debris (clothing, ribbon, plants) were attached. Large debris included corrugated iron roofing. Encrusting corals were intact.

Many small corals (*Acropora* sp.) had branches broken off and debris (clothing, ribbon, plants) were attached. Large debris included corrugated iron roofing. Encrusting corals were in tact.

The rock wall cladding of the shoreline above the waterline was ripped apart with boulders and rocks scattered below the wall and smaller rocks thrown over the road. The ramp was not affected. On the reef flat and upper reef slope, encrusting corals were not damaged. Most *Pocillopora* colonies were fine, though a couple had most of their branches broken off. Most *Acropora hyacinthus* recruits were damaged, perhaps around 80%. Some were broken around the edge of the table top. Others had only the encrusting base and the base of the pedestal left. Many were intermediate with significant damage to the table top. Many had clothes or grass or other human debris caught on the table. A few had dead areas in the center that were covered with dark green turf, and thus that area had died some time prior to the tsunami, probably weeks to months earlier. Many had areas around their edge that did not look healthy. Corals other than table recruits on the slope and reef flat looked healthy, but some other *Acropora* colonies had broken off branches. There were some pieces of corrugated iron roofing on the slope at around 20 feet deep. There was no sand or rubble visible. One area in a crack looked scoured with white rock surfaces. Rocks near the shore had white areas where they had been hit by other rocks. It appears that there may have been a number of rocks moved back and forth over the crest area breaking corals.

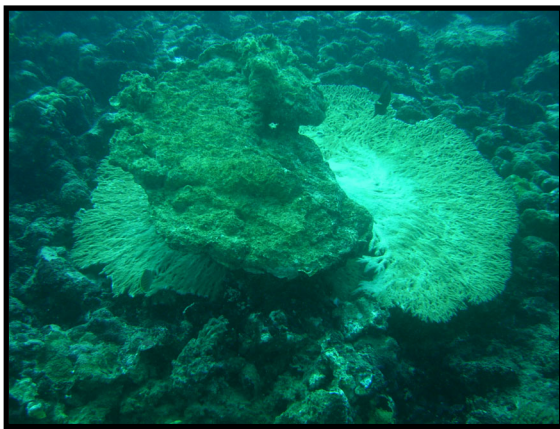
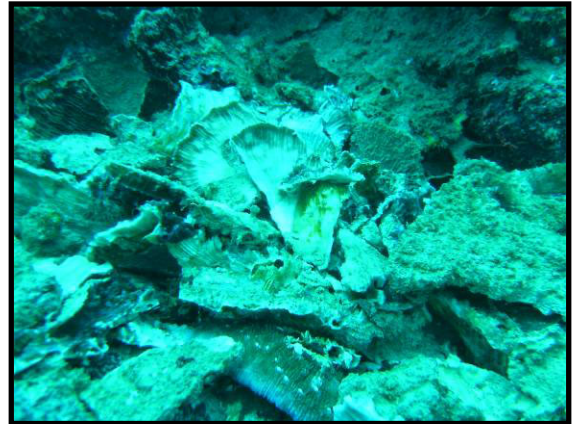
Faga'alu

Slope: Majority of the damage was found at 20m depth were plate corals (*Mycedium sp*) were broken and overturned. Fungiids were also overturned at this depth. Minimal damage or debris was found in shallower areas. Fagaalu pool: Staghorn coral (*Acropora muricata*) was extensively damaged.

Only minor damage to *Porites cylindrica* (finger coral). A few branches were broken off in a few places, a few small colonies thrown around. But damage to the staghorn (*Acropora muricata* = *formosa*) was extensive. There are large areas in which the staghorns were moved and broken and jumbled up with the dead staghorn that was beneath the living staghorn. The dead staghorn was light colored, had some coralline algae on it, but no filamentous algae. There are also smaller places that look like a bulldozer went through, with nothing but sand and rubble. In one spot, large amounts of sand were removed, leaving white reef rock that had been covered by sand. A depth of over 5 feet of sand had been removed from that channel through the reef.

Below about 20m, most of the plate corals (*Mycedium*) were flippend and jumbled with plate rubble, all surfaces not alive were covered with brown turf. Some fujngiids (mushroom corals) were flipped upside down. In one area, healthy untouched plate *Mycedium* up slope shallower than 18 m had plates close together, and may have been better attached. There was a sharp dividing line between where plates below moved, but above they were untouched. There were some streaks where *Acropora* stick rubble was moved, with brown stick rubble revealed that was below what was removed. Past the bend on the ridge that sticks out, everything was rubble, but most had not been moved. There were a couple of sandy areas. Shallower areas were undamaged except for a few spots where corals or rubble were moved. There was no damage at the crest in just a couple feet of water.

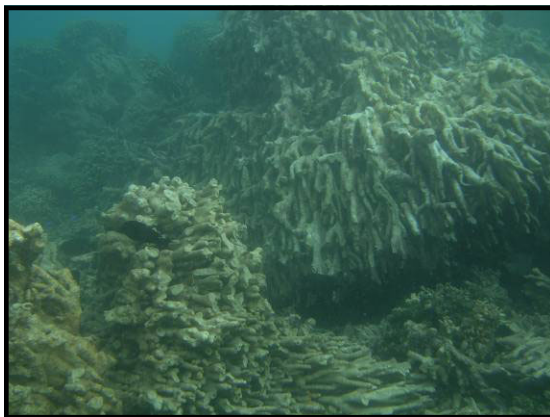
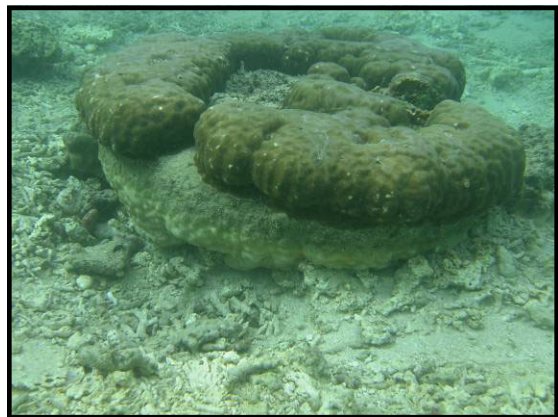
Near shore damage was present but not severe. In certain areas, severe damage included broken massives and staghorn corals. Debris was mostly nearshore and minor.

Near to shore on the sand flat there are several small finger coral heads (*Porites cylindrica*) that were not there before. They appear healthy, but it is not clear whether they can survive near shore. In the deep pool, some of the staghorn on mounds was moved or broken, but some is intact. In the shallow area to the west of the deep pool, damage is severe. Many of the large *Porites cylindrica* mounds were moved or broken or smashed. So much of the staghorn was tumbled, broken, and mixed with rubble that it is hard to find the staghorn areas I used to assess for bleaching. The only small patch of the staghorn *Acropora nobilis* I knew in Alofau was completely missing. Disturbance was so severe that I could not recognize where I was. An area where there was a deeper connection to the next pool to the west was scoured out and much deeper. Approaching the reef flat there is an area of *P. cylindrica* that was in the pool next to the reef flat. This finger coral was very heavily damaged, broken, tumbled, etc. The inner reef flat is unrecognizable, with scour removing considerable amounts of the rubble that was there, perhaps about 30 cm deep. A bit farther out, most of the larger microatolls remain, some with the substrate level around them lowered. A few smaller massive *Porites* heads were overturned. Farther out, a sharp line is reached where the original coralline-algae encrusted rubble bed remains, but at a sharp edge the substrate drops about 20 cm to a white rubble bed of newly exposed rubble that had been previously buried. Farther out the corals on the outer reef flat appear just as they were before the tsunami, with no visible damage. On the upper reef slope the only damage was to table corals. Most tables were undamaged, but a few had pieces broken off of their edges. Farther down the slope there were several large pieces of table corals. One *Pocillopora* had most of its branches broken off. But all other corals appeared untouched.

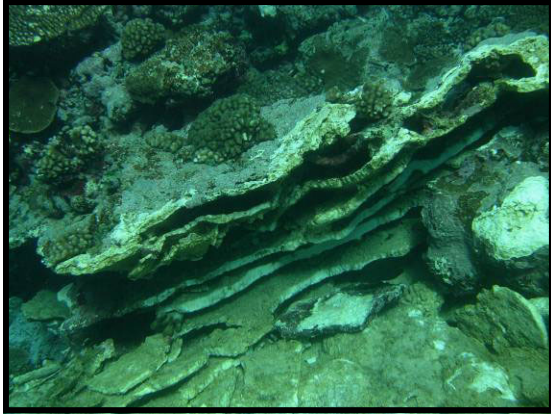
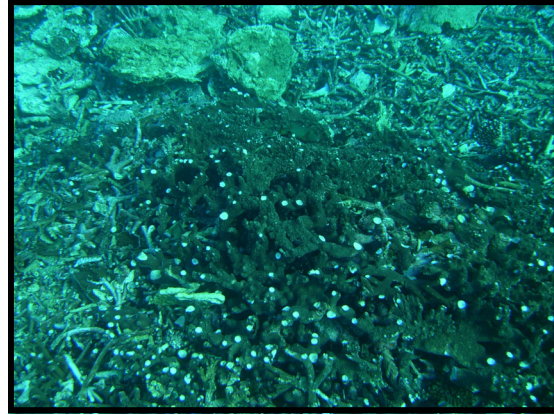
Fagatele

Extensive damage on the shelf, ridges survived and gullies were filled with freshly overturned rubble. Several large growths of the thin plate coral, *Echinopora lamelosa*, up to about 20 feet across have disappeared. Little damage below 40 feet.

Extensive damage on the shelf, ridges survived and gullies were filled with freshly overturned rubble. Several large growths of the thin plate coral, *Echinopora lamellosa*, up to about 20 feet across have disappeared. Little damage below 40 feet.

All plants on the ground at the base of the rock wall above the beach were removed except the tree. Plants were damaged up to about 20-25 feet above the water level. The stairs were fine. Damage was extensive on the “shelf,” that is the nearly flat slope between about 10 feet deep (at the dropoff from the reef flat) and 40 feet deep. Upward projecting ridges had little damage, with live coral and coralline algae cover as before, though some coral branches were broken. Gullies and flat areas between ridges were covered with debris/rubble, most of which was a light yellow and long dead. Pieces up to about a foot diameter dominated. There is zero live coral in these debris areas. The debris appears to be debris from previous events such as the hurricanes or crown-of-thorns outbreak, which had coralline algae growing over it, but was ripped up by the tsunami and spread around. There were a few larger blocks, the largest of which was about 8 feet by 4 feet. There had been several large growths of the thin plate coral, *Echinopora lamelosa*, up to about 20 feet across, but no trace of any of those growths were found. Below about 40 feet deep it appeared that there was little damage, and most of the damage was to table corals.

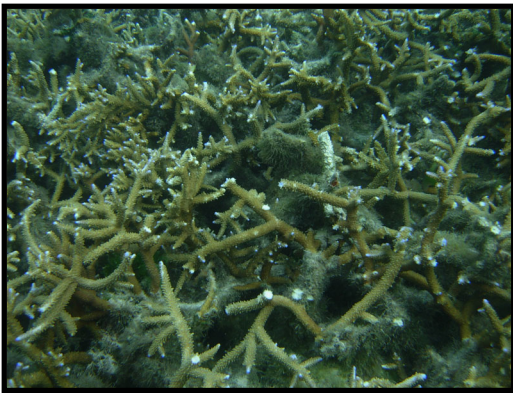
Fagaitua

There were extensive damages to the staghorn coral fields and mixing of rubble. Staghorn corals were reduced to rubble and moved to other parts of the reef. Debris was minimal.

Extensive damage to staghorn coral fields and mixing of rubble. Debris was minimal.

This shallow area also appears to be a natural backreef pool, and had extensive beds of the staghorn coral, *Acropora muricata* (= *Formosa*). As of about 2004, this continuous bed of staghorn was all alive with essentially no dead coral. Since then low tide events and bleaching impacted it, with low tides killing the highest growing branches, and bleaching killing some other corals. It had recovered partway when the tsunami struck. Now, the bed has been disturbed heavily, rolled and churned much like the staghorn in Fagaalu. In almost all of the bed, the older dead branches that had underlain the living branches now predominate in a rubble bed, with some branches of living staghorn mixed in. Most of the living staghorn consists of broken branches. There are a few small areas of about 1-2 sq meters that appear much as they did before.

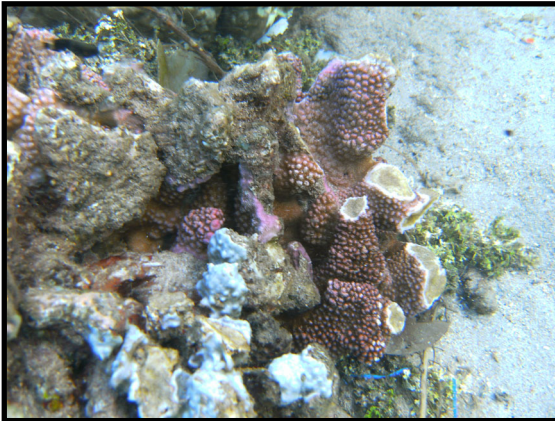
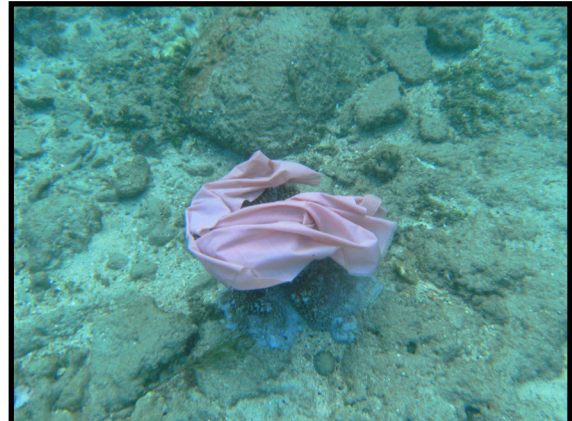
Poloa

Encrusting corals were undamaged but the majority of small branching and table corals had snapped branches. Coral reef is not well developed but the impact on extant colonies was severe. Many corals had debris attached. Large debris was also present including corrugated iron roofing.

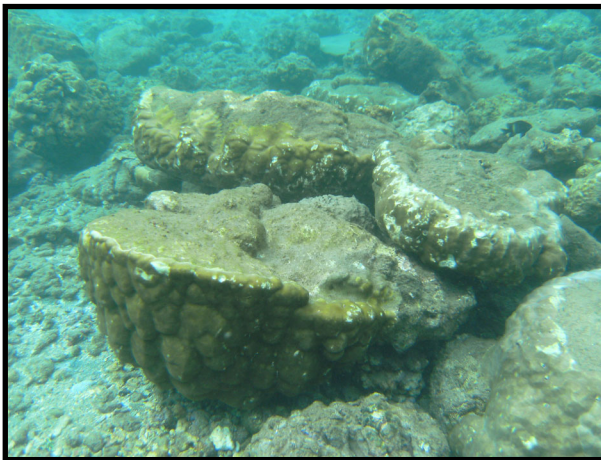
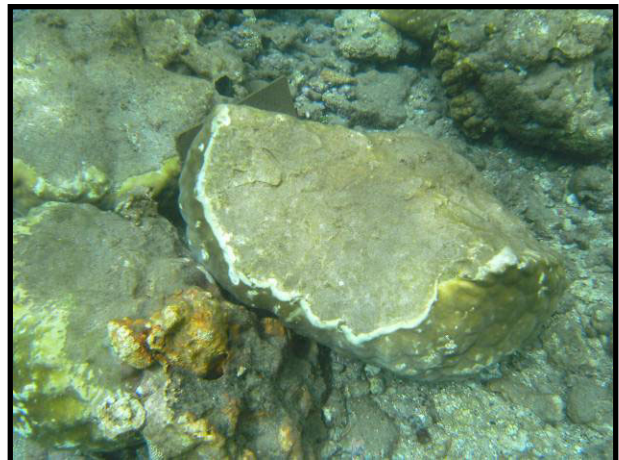
Leone

The reef flat was dominated by damaged massive corals. Coral rubble was high. The force of the water in some areas of the reef was apparently very high with massive corals were reduced to pieces. Numerous massive corals were also overturned and in many cases broken. Some coral colonies were moved to inappropriate habitats (sandy and muddy substratum). Some colonies ended on the beach indicating the dominant on shoreward force of the tsunami.

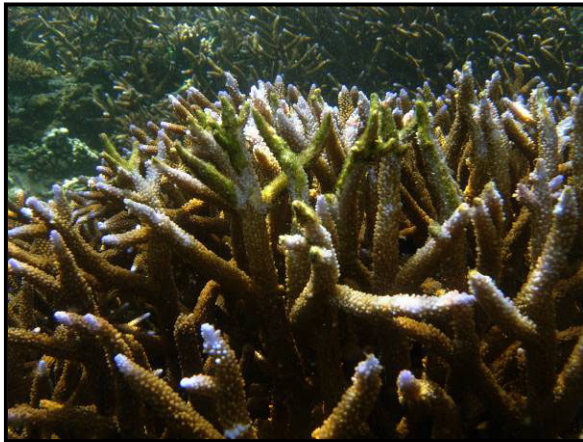
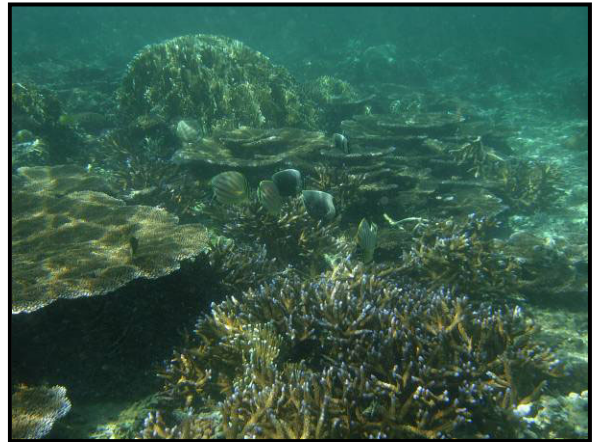
Onesosopo

This shallow and apparently natural pool is located near the Origin gas facility in Onesosopo, and has abundant coral of a number of species in about 3 feet of water. The corals were almost entirely intact, with a very few small colonies that were not attached that were overturned, and at least one colony with broken off branches.

9. Onososopo pool: 10/3/09. This shallow and apparently natural pool is located near the Origin gas facility in Onesesopo, and has abundant coral of a number of species in about 3 feet of water. The corals were almost entirely intact, with a very few small colonies that were not attached that were overturned, and at least one colony with broken off branches. But the rest of thousands of colonies that were observed showed no damage, and there was no evidence of scour, sand, rubble or anything else indicating damage.
